INSPECTION REPORT ESSO TUTU SERVICE STATION TUTU WELLFIELD REMEDIAL DESIGN/REMEDIAL ACTION OVERSIGHT ST. THOMAS, U.S. VIRGIN ISLANDS

Date Prepared : July 2, 1999

INSPECTION REPORT Esso Tutu Service Station, St. Thomas, USVI

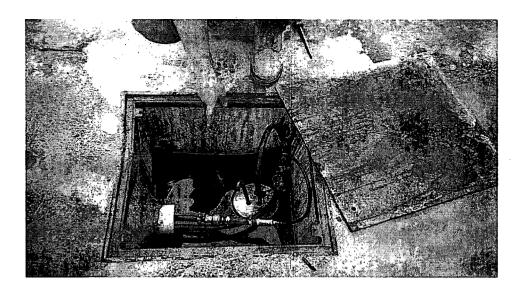
Typical deep groundwater extraction well (Location G7).

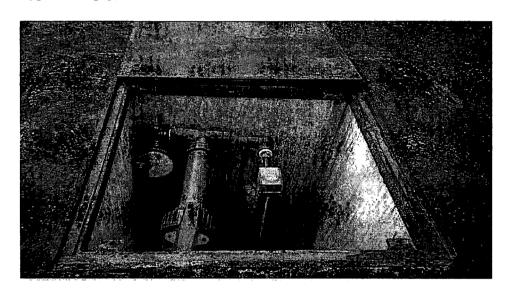
Typical SVE well (Location V5).

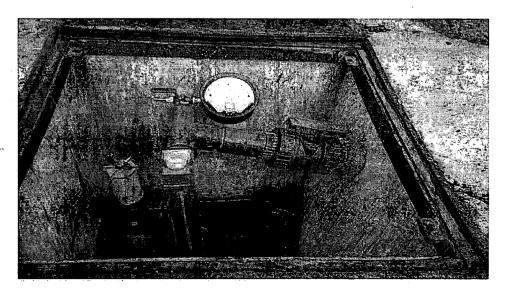
Typical bioventing extraction well (Location BE5).

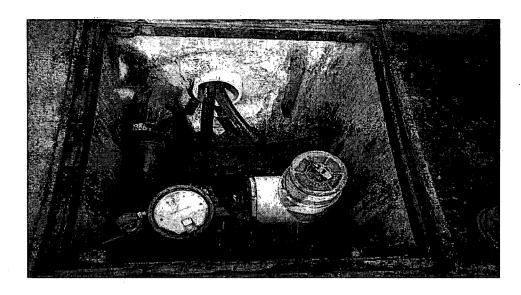
Typical shallow groundwater extraction well/bioventing injection well (Location G2/BI).

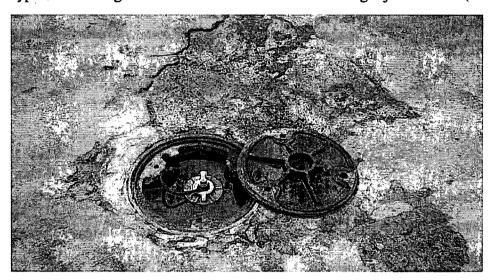
Typical vapor monitoring point (Location VW1).

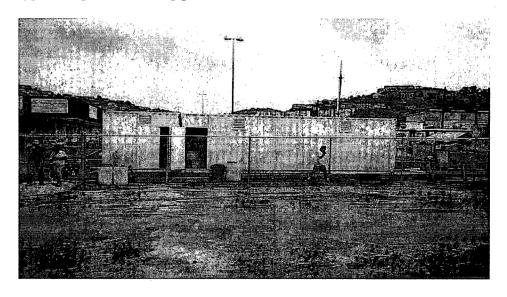
North view of treatment system trailer.

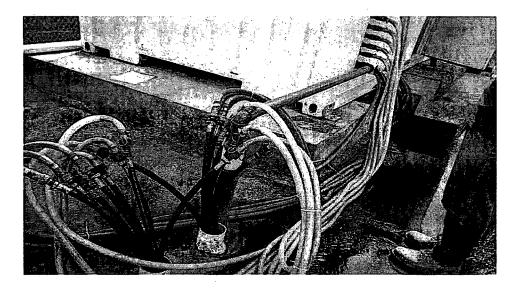
Outside the treatment system trailer, the influent PVC pipe entrances into the trailer were observed to be exposed to the environment. Esso's consultant indicated that a protective cover system for this location was currently being pursued. The treatment trailer was observed to be anchored to two strip footings, such that the trailer is elevated approximately two feet above grade. Esso's consultant indicated that hurricane forces had been considered by Esso's construction contractor (Bell & Hill) in designing the trailer foundation, and that the stack for the catox (located outside of the trailer) could be readily disassembled, when necessary. The catox is anchored to a concrete pad located adjacent to the east side of the trailer. The treatment trailer and catox are secured by perimeter fencing equipped with a lockable gate.

View of groundwater influent lines surfacing and entering the trailer.

- The groundwater and SVE piping exposed at the ground surface by the trailer should be equipped with added protection to prevent the PVC pipes from deteriorating as a result of extended ultraviolet light exposure.

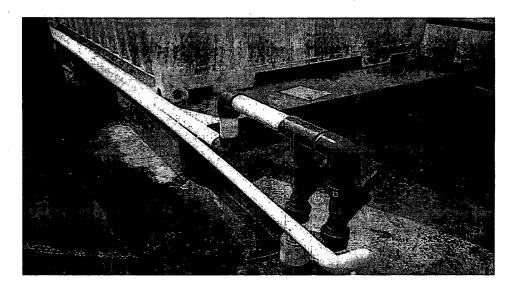
View of SVE and bioventing influent lines surfacing and running along the north side of the trailer to the catalytic oxidation unit.

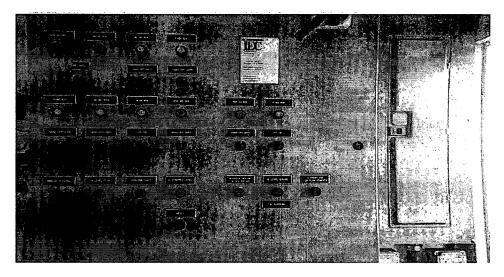
Main Control Panel for the treatment system.

- Installation of an air conditioner in the control room is suggested to protect the electrical and control equipment from potential damage associated with extreme heat and humidity.

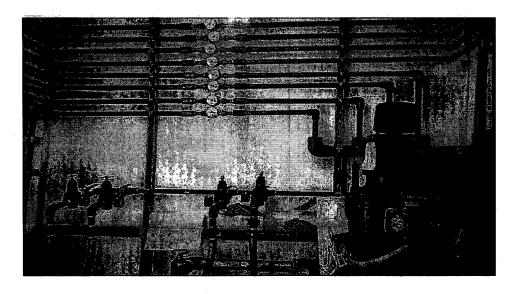
The control room included a main control panel (MCP), programmable logic controller (PLC), and autodialer. The influent lines of each extraction well were observed to enter the control room separately and be equipped with mechanical-type flow totalizer; no flow meters were installed. It is also noted that there were no meters or recorders for monitoring performance of the air stripper blower. All of the deep wells, excluding G5, were observed to be operating. During startup testing, G5 was determined to contain a significant amount of floating product. Esso's consultant indicated that efforts to removed the product are ongoing. None of the shallow wells were observed to be operating. Esso's consultant indicated that the shallow well pumps were not in place during the inspection; however, they had been previously tested and determined to be fully operational. It was further noted that these wells currently contain little or no water, likely due to the dry season and deep well pumping.

View of groundwater influent lines and flow totalizers inside the control room.

- The influent lines from each groundwater extraction well and the combined influent header should be equipped with flow meters to minimize longterm O&M efforts associated with monitoring the system, trouble-shooting operational problems, and optimizing system performance.

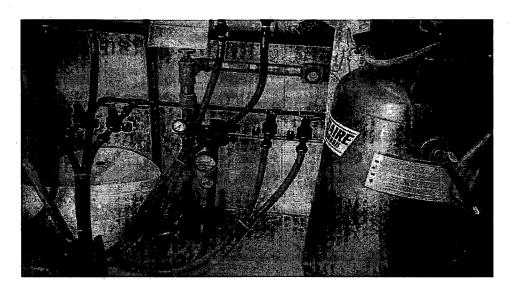
View of the compressor for the pneumatic pumps inside the control room.

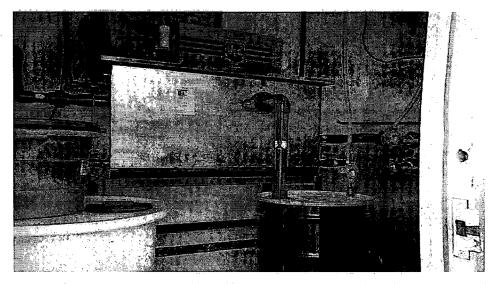
View of the sequesterant tank, oil/water separator, and product recovery drum inside the equipment room.

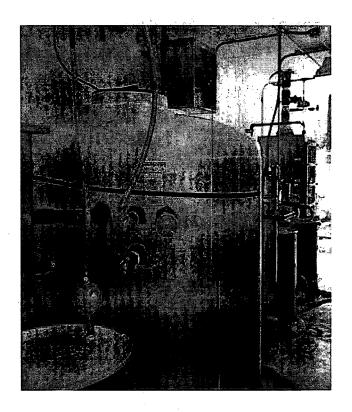
View of the groundwater stabilization tank.

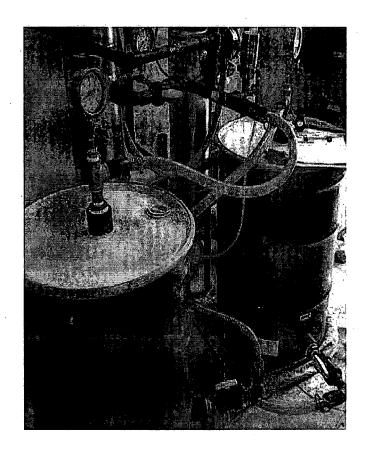
View of the liquid-phase activated carbon units.

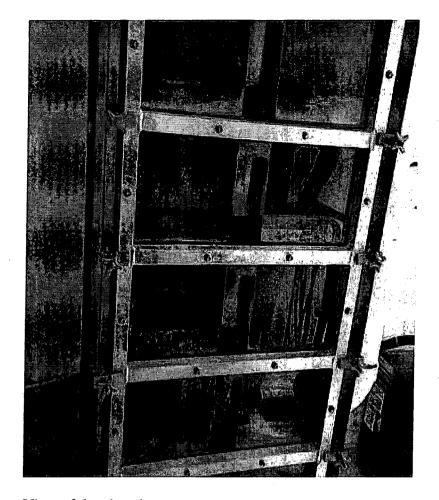
View of the air stripper.

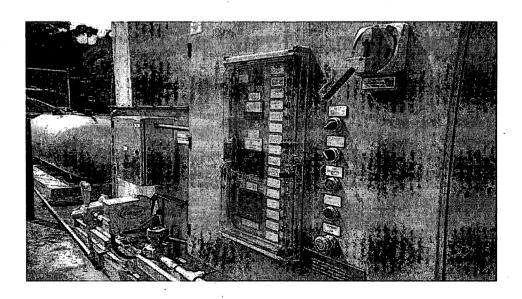
View of the sub-panel for the catalytic oxidation unit.

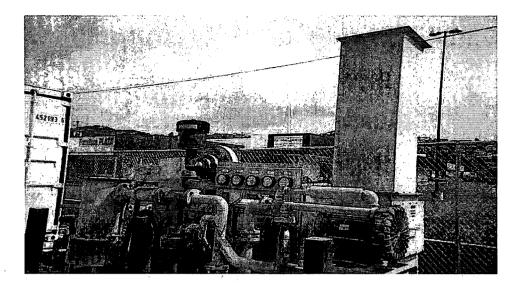
North view of the catalytic oxidation unit, showing the knockout drum, blower, and exhaust stack.

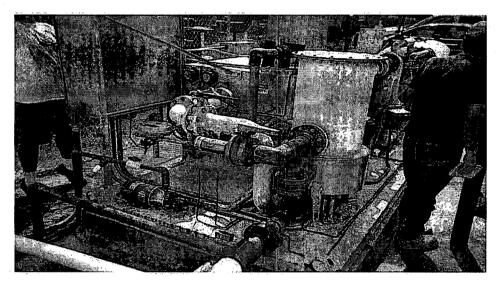
View of the vapor influent line entering the knockout drum.

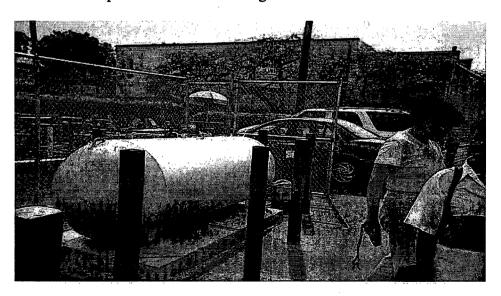
View of the fuel tank for the catalytic oxidation unit.
